Study on coating exfoliation damage of KDP component under laser irradiation by surface analysis

Potassium dihydrogen phosphate (KDP) is a key component for laser frequency conversion. Here, we study the damage of KDP coating caused by multiple laser irradiation under low flux in vacuum. Time-of-flight secondary ion mass spectrometry (ToF-SIMS) with $C60^{n+}$ cluster sputtering in combination with scanning electron microscopy (SEM) and atomic force microscopy (AFM) were employed to provide detailed information on the three-dimensional chemical composition and the deterioration process of this kind of coating. The detailed chemical changes in the process of coating densification caused by UV laser irradiation were explained by analyzing the coating thinning after irradiation. The conversion from Si-O-Si bond to Si-O-K bond supported coating hardening after damage. Furthermore, a dynamic evolution law of coating deformation after laser irradiation was obtained by comparing it with non-irradiated coating. Interface bonding between KDP and coating, stratified chemical information across the coating thickness direction, and relationship between damage and environmental condition were

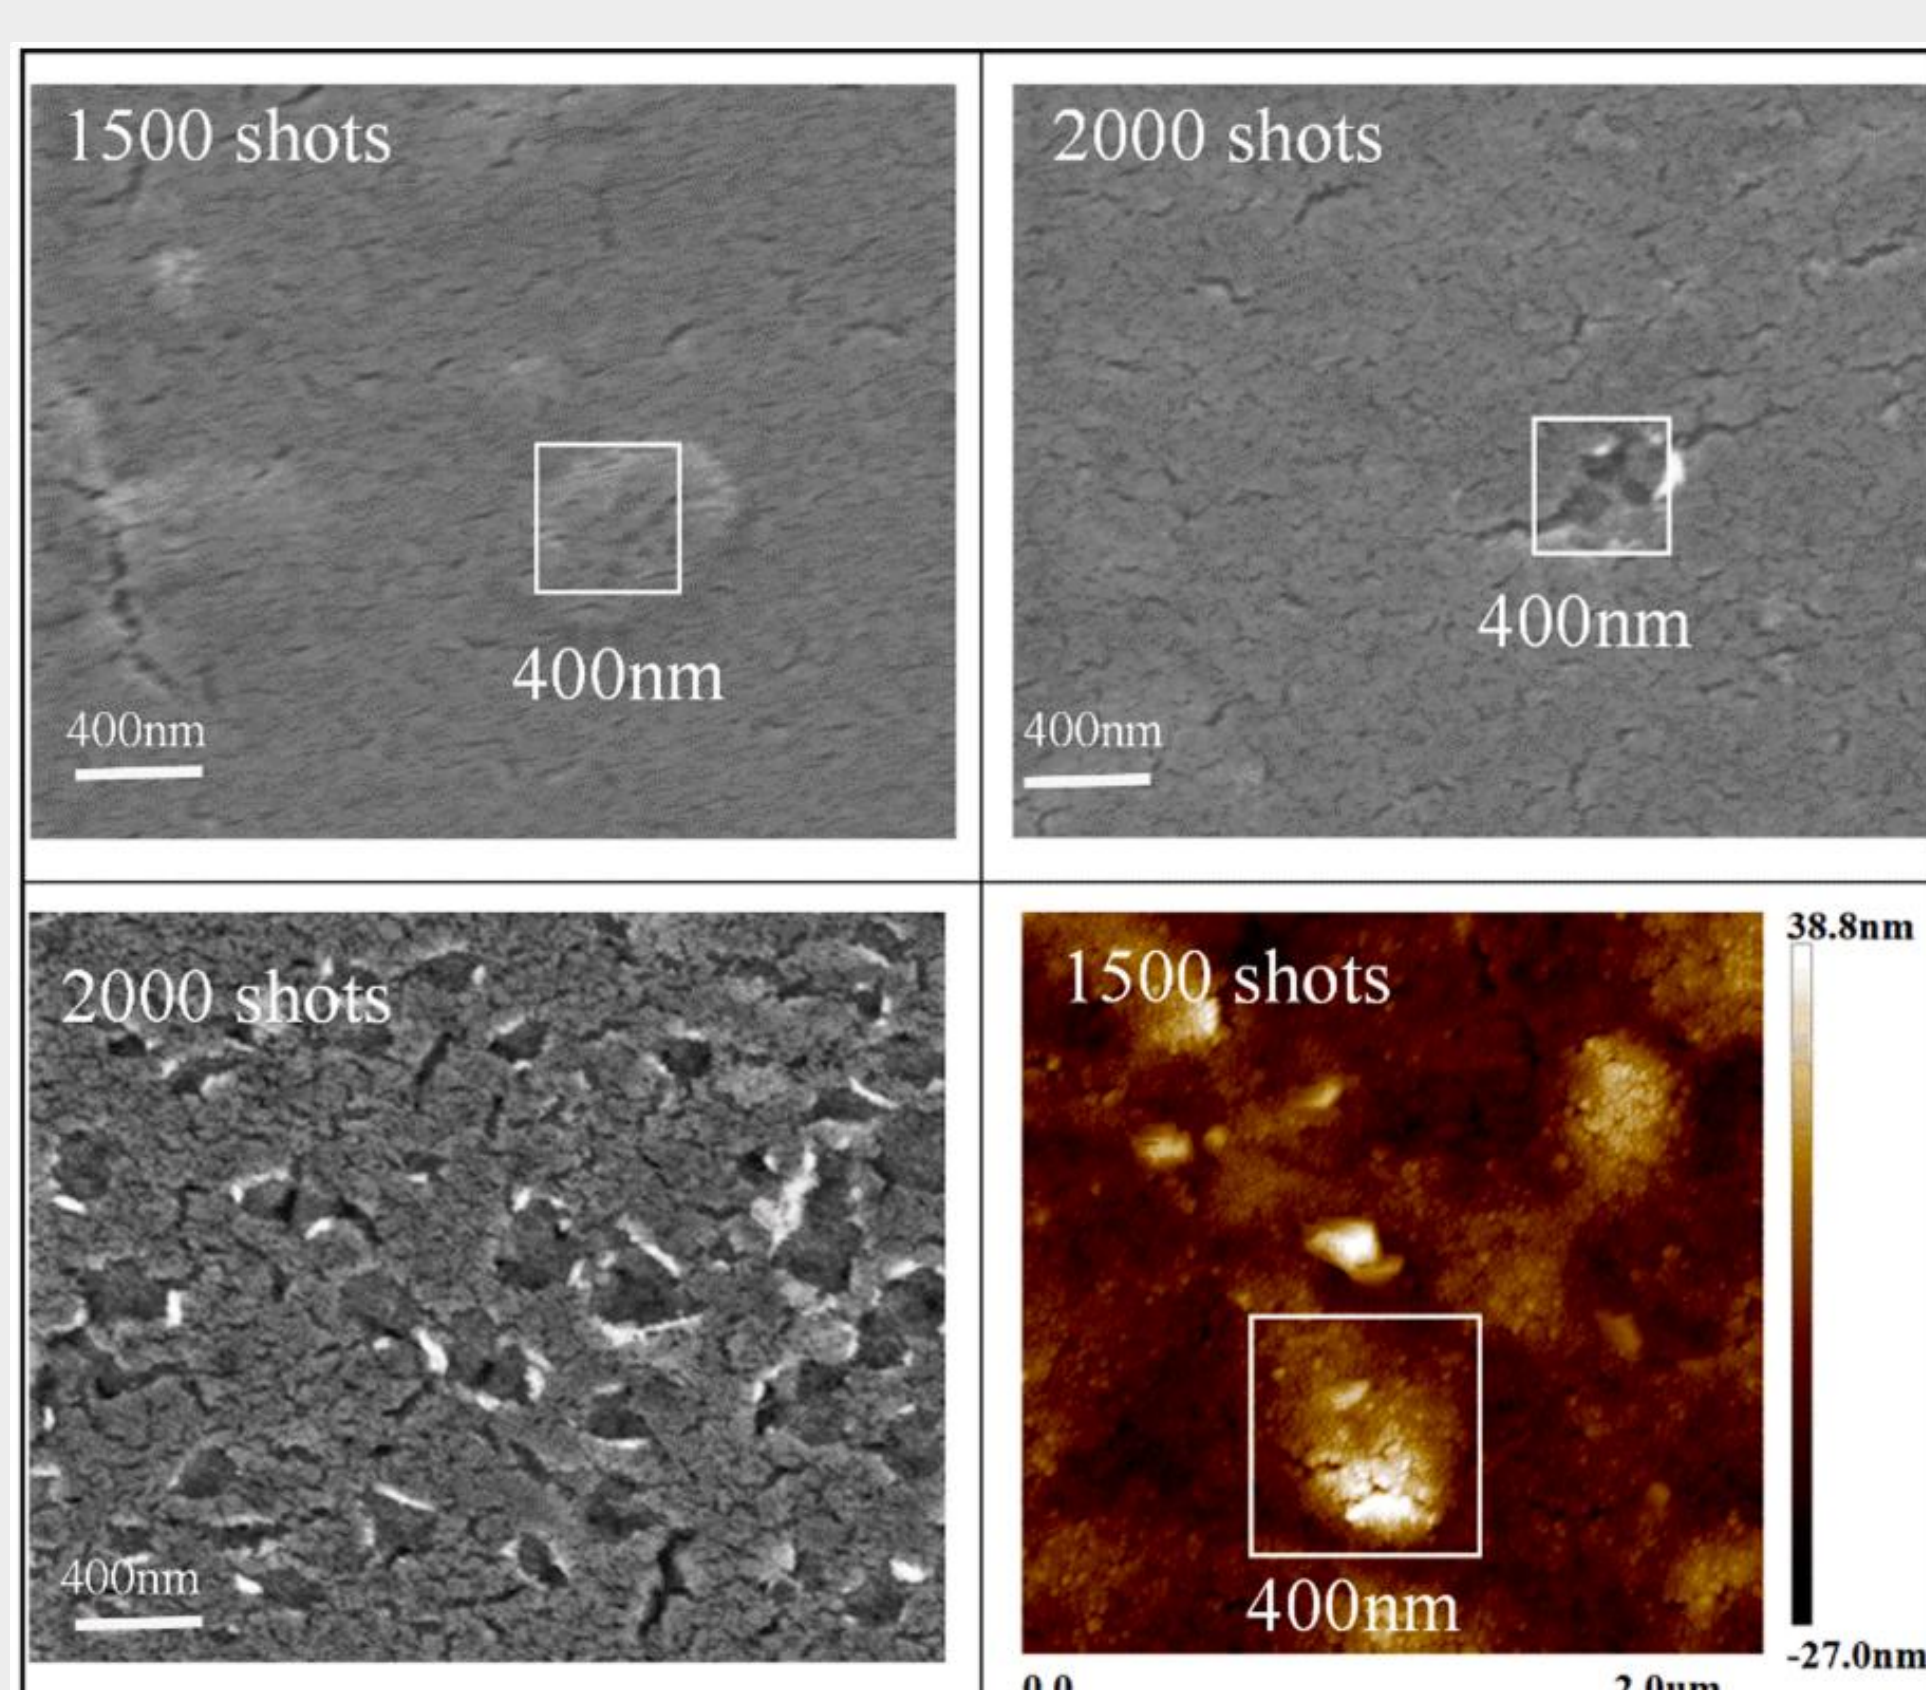
In this experiment, KDP AR coating sample was irradiated by **1500, 2000 and 2500 laser pulses** individually, and the laser pulse width valued **8ns**, the pulse energy density is **4J/cm²**.

Fig 2: Results of experiment irradiated by laser pulses

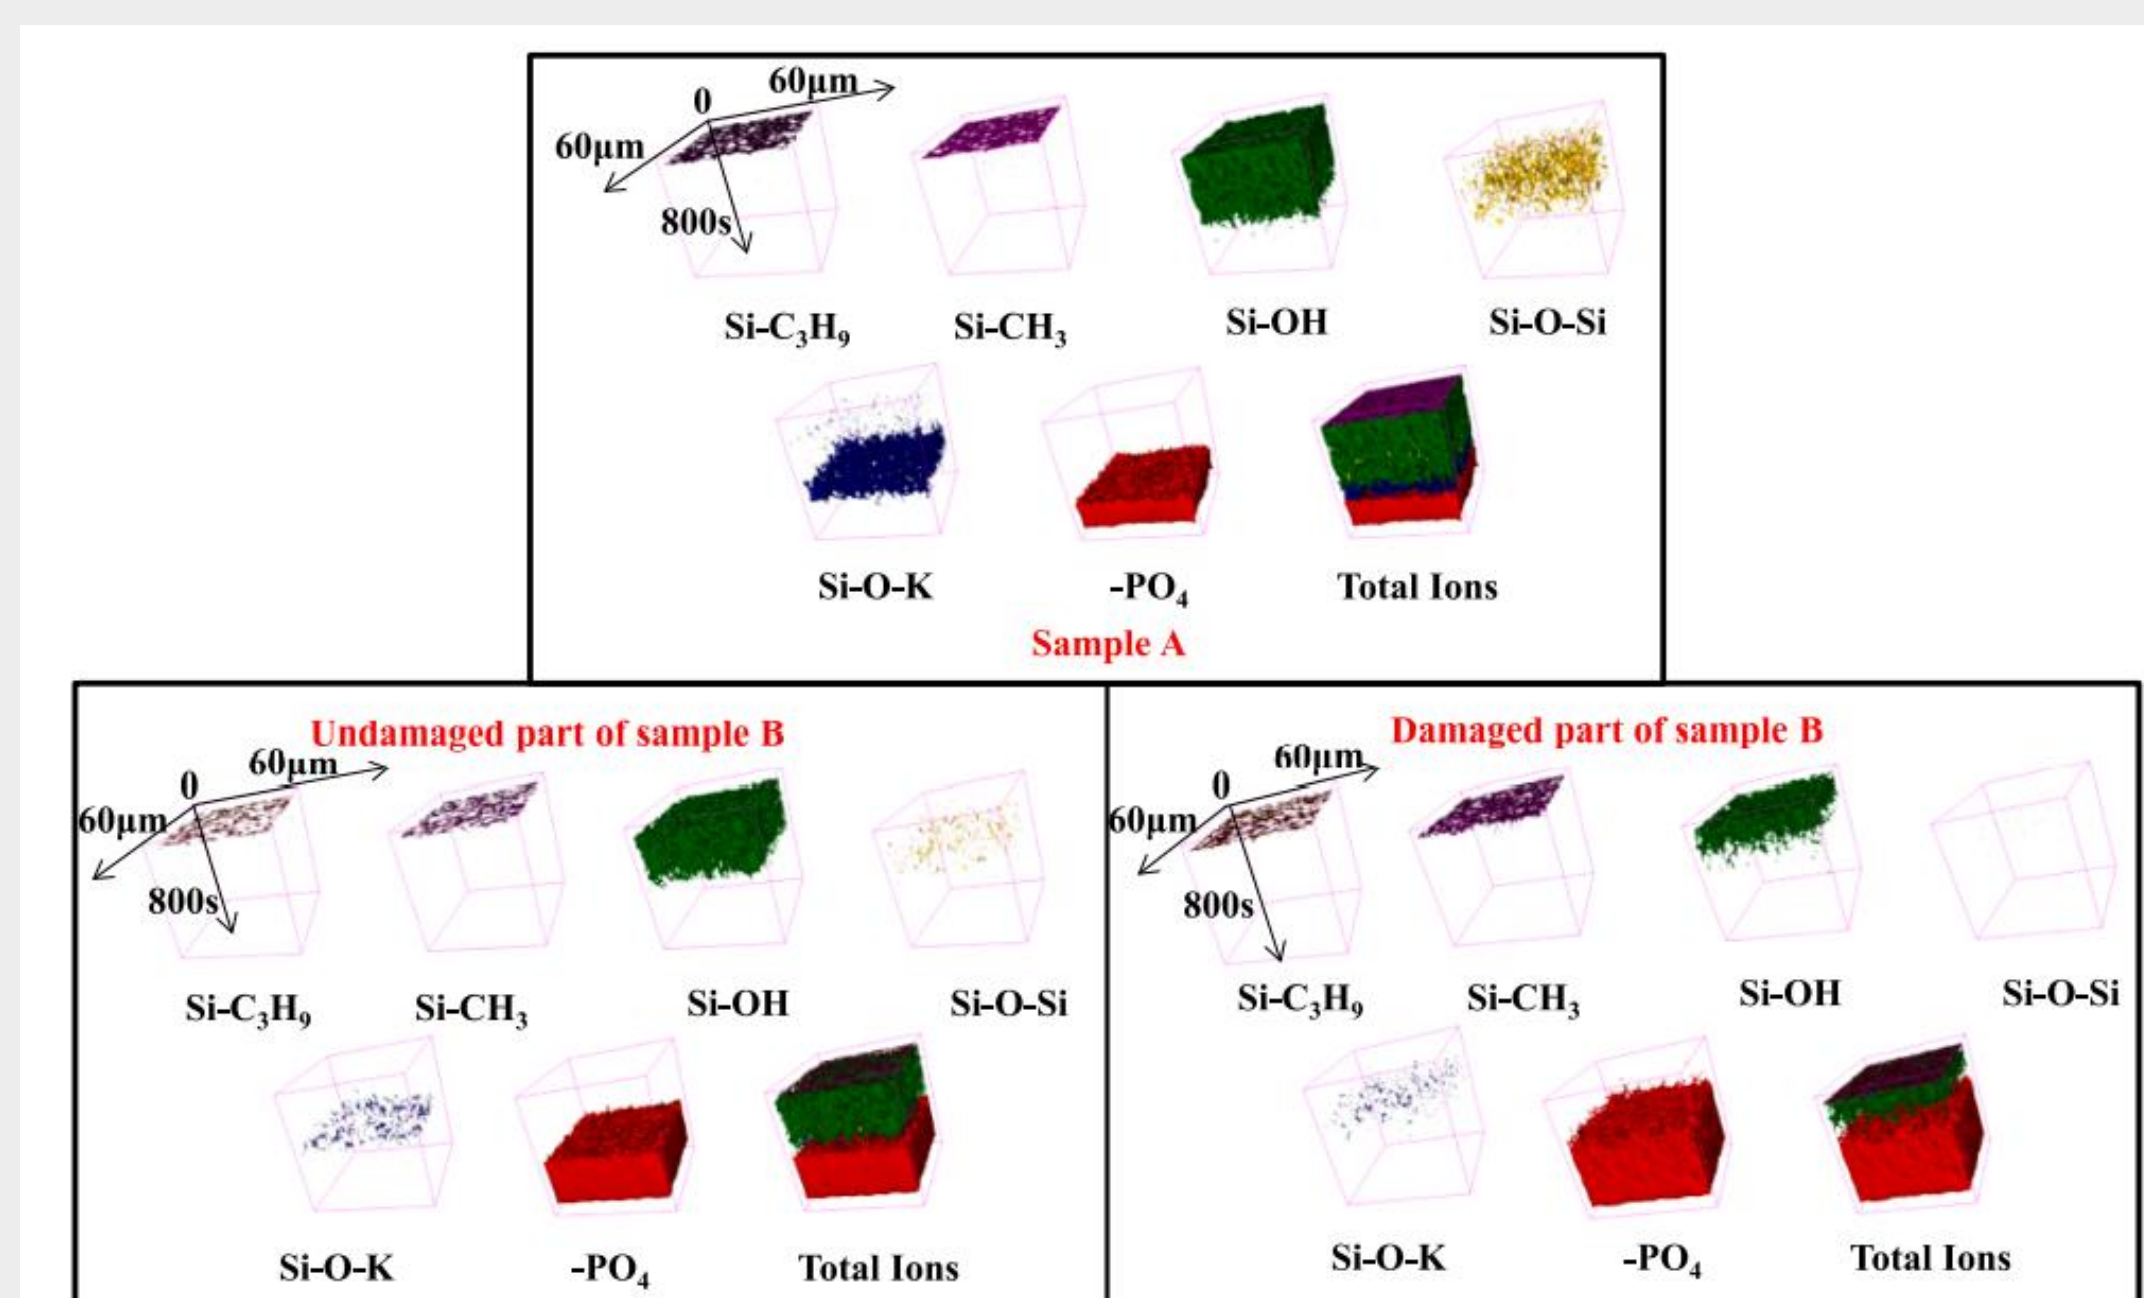
Relative atomic mass(m/z)	Product	As-Prepared coating	Undamaged part	Damaged part
73	Si-(CH ₃) ₃	7495	3996	8291
43	Si-CH ₃	9788	6125	14,632
45	Si-OH	90,177	43,014	40,834
72	Si-O-Si	34,956	13,207	6959
83	Si-O-K	39,625	10,403	17,791
95	P-O ₄	182,717	144,624	192,074

Fig 3: Results of coating chemical structure by ToF-SIMS

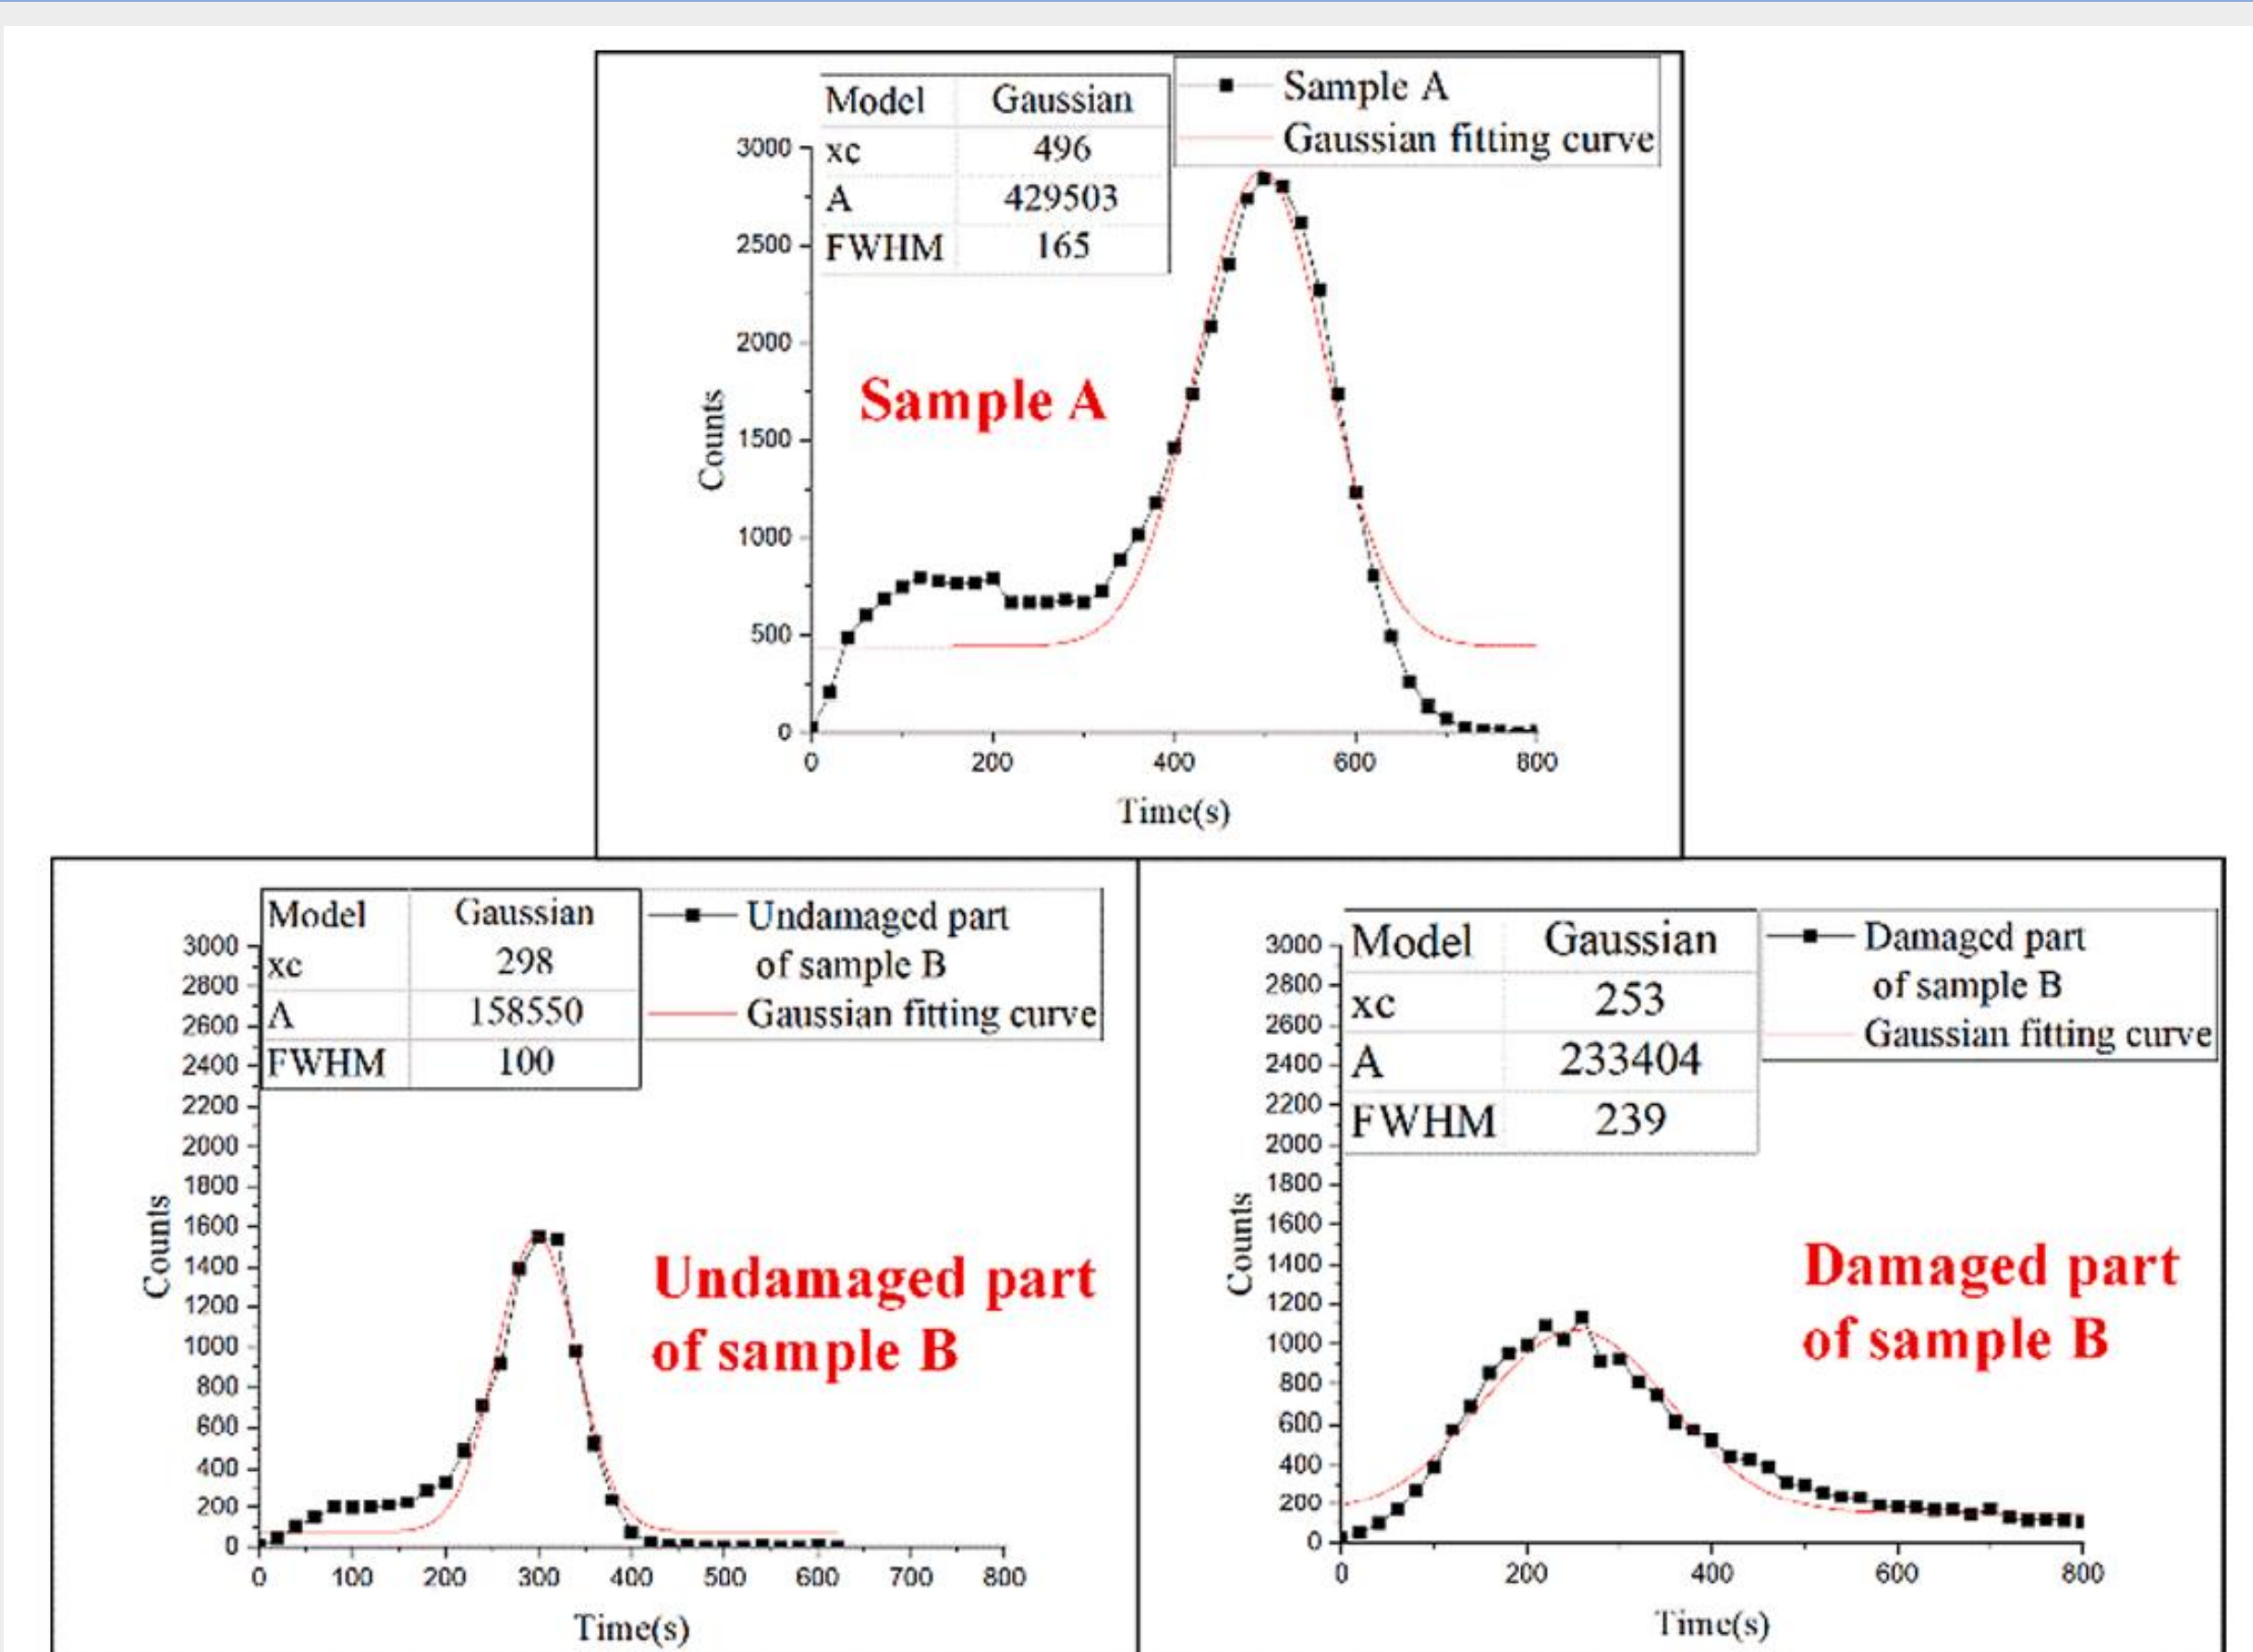
Fig. 4: Gaussian fitting curves of Si-O-K bond content in three coating states.

Clear exfoliation damage was confirmed over the antireflective laser coating applied for KDP component which exhibited whitish damage visually. The chemical information of this coating was reconstructed via ToF-SIMS analysis, in which Si-O-K was verified to be the connection structure at the coating/substrate interface as well. The loss of porosity upon porous laser coating was found the most crucial reason to cause damage under low-flux laser irradiation, and the coating densification and organic pollution was proved to be responsible for the porosity loss through experiments. Initial humping deformation over this coating was identified at the beginning of laser interaction, and further burst and connection of this deformation would finally result in the large-area whitish macroscopic damage.
